SERVICE BULLETIN

Health Imaging Products

SERVICE BULLETIN NO. 303

SEPTEMBER 2002

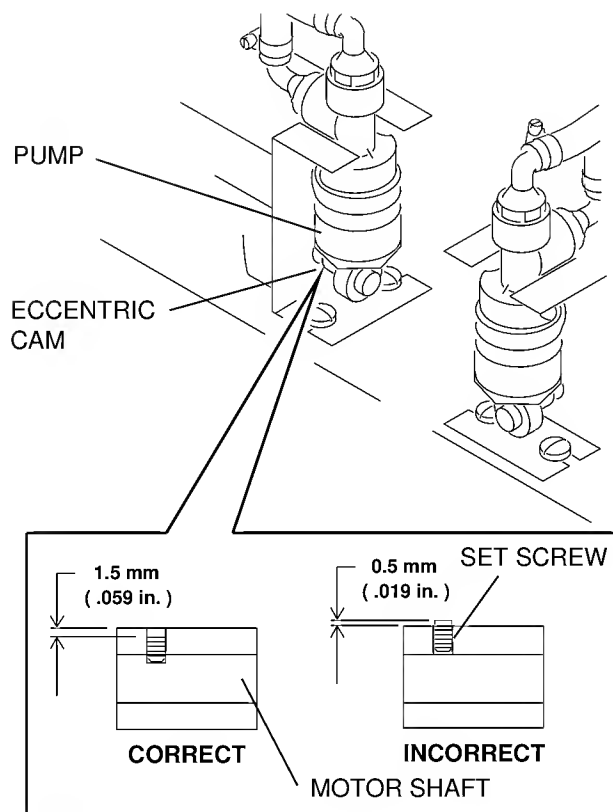
H127_0258GCA
H127_0258GC

On some of the REPLENISHMENT PUMPS, the SET SCREW that holds the ECCENTRIC CAM in place on the MOTOR SHAFT was incorrectly assembled. If the PUMPS were incorrectly assembled, there is a high risk that the ECCENTRIC CAM may slip on the SHAFT, resulting in no replenishment when the PUMP runs. This condition may result in a user complaint of the sensitometry going out of control, caused by lack of developer replenishment, or improper clearing or washing of the film, caused by lack of fixer replenishment.

When correctly assembled, the SET SCREW is designed to tighten into a hole on the MOTOR SHAFT. On the PUMPS that were incorrectly assembled, the SET SCREW was not aligned with the hole, and was tightened directly onto the SHAFT.

On **correctly** assembled PUMPS, the top of the SET SCREW will be approximately 1.5 mm (.059 in.) below the top of the screw hole.

On **incorrectly** assembled PUMPS, the top of the SET SCREW will be approximately 0.5 mm (.019 in.) above the top of the screw hole.

If the PUMP is found to be incorrectly assembled, do the following:

- Remove the SET SCREW, and rotate the ECCENTRIC CAM on the MOTOR SHAFT to line up the SET SCREW hole with the hole on the MOTOR SHAFT.
- Install the SET SCREW in the ECCENTRIC CAM and tighten the SET SCREW into the screw hole.

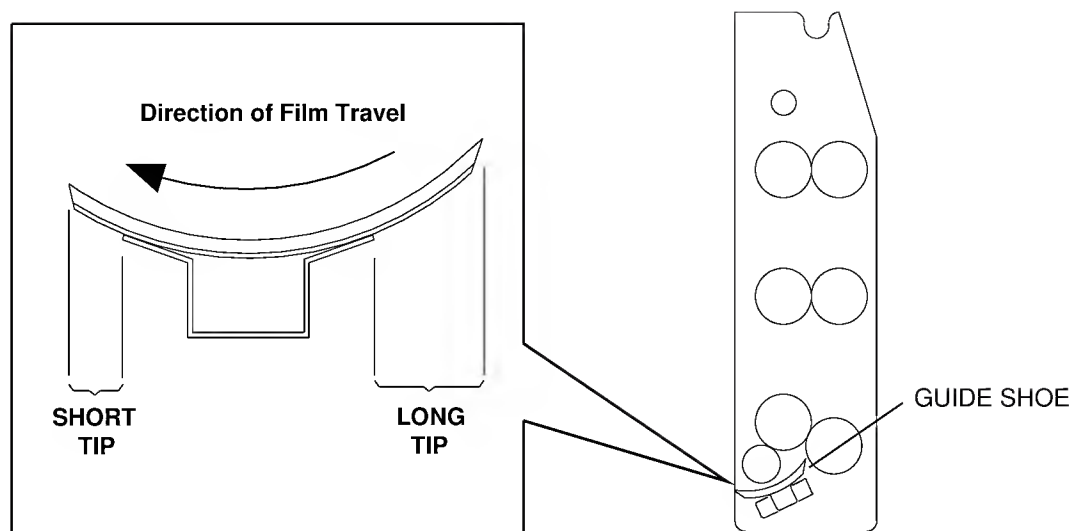
H127_0259BCA
H127_0259BC

If you are experiencing film jams at the WASH RACK exit, check the guide shoe on the wash rack for correct orientation. This applies to 180 LP/LPS, 270 RA, 270 INTEGRATED, 3000 RA INTEGRATED and 3000 INTEGRATED PROCESSORS. The service manual does not point out clearly the orientation of the long and short side of the guide shoe. Refer to the illustration below. It would help to save this bulletin or make a note in your service manual.
